Subject: Sunshine Canyon Landfill, Quarterly Vegetation Report
First Quarter 2024 Vegetation Report

This report presents the progress of the site's landscaping and revegetation activities for the first quarter of 2024. The intent of these reports is to provide detailed information regarding the site's efforts related to vegetation including vegetation of interim and permanent slopes and activities conducted for the on-site sage mitigation areas.

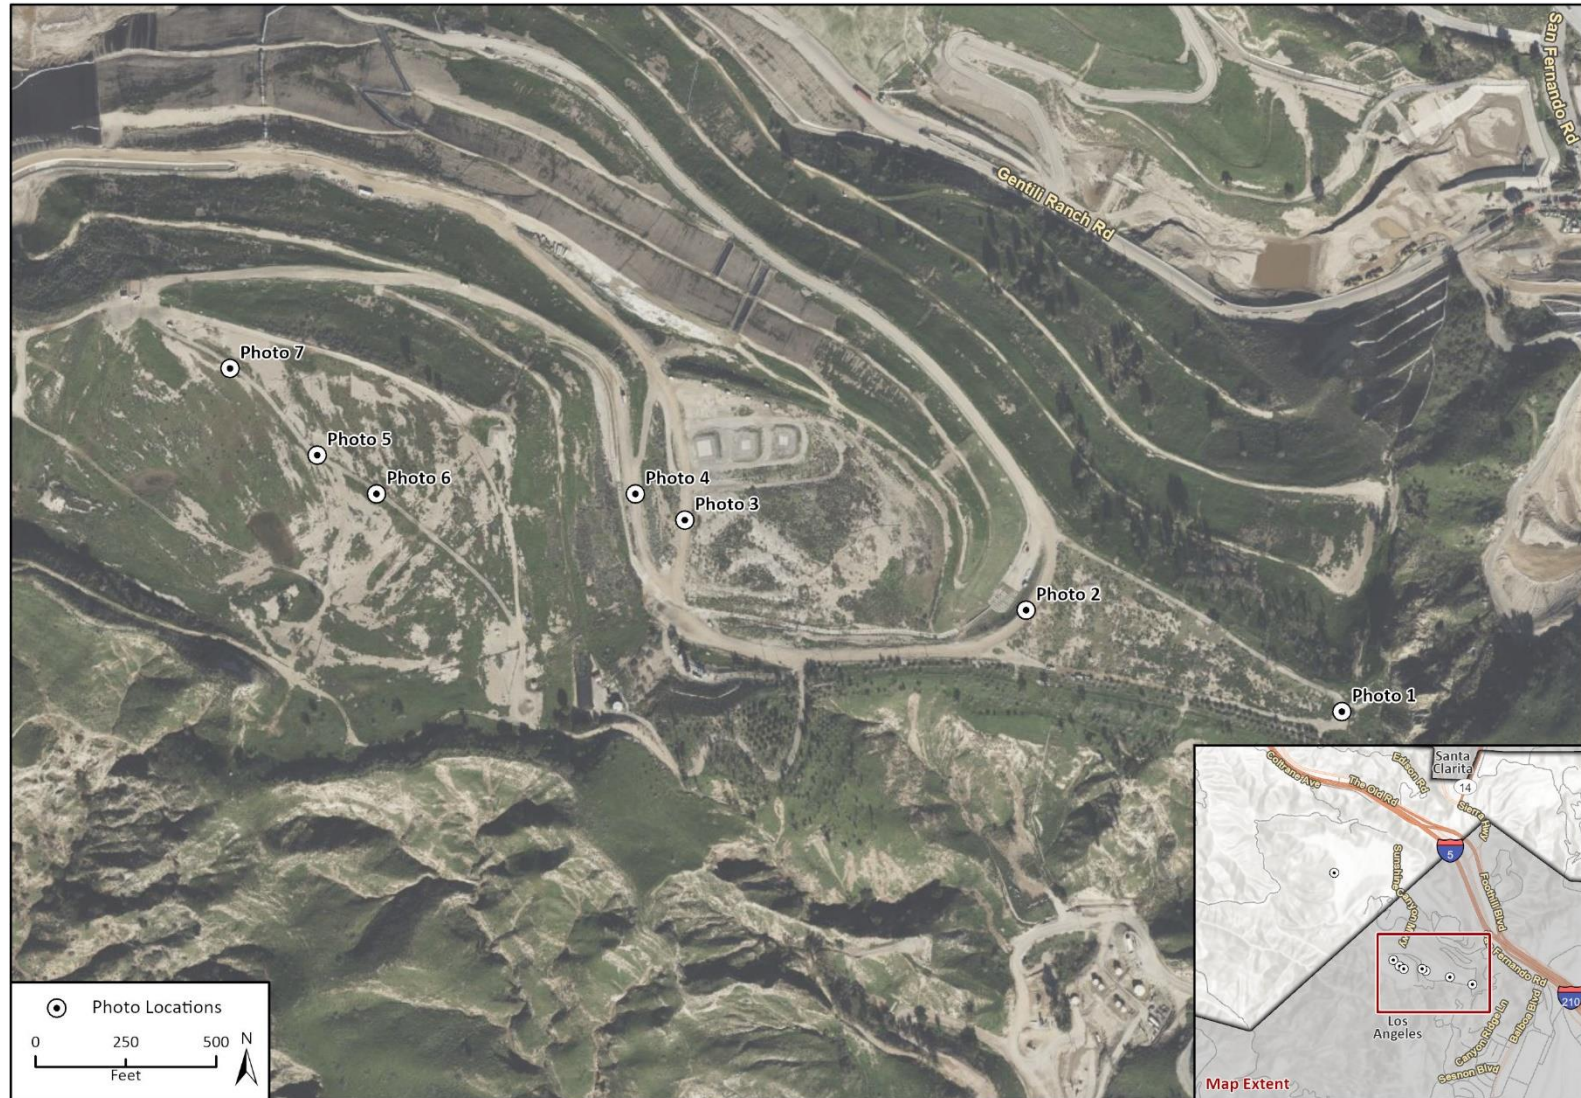
Figure 1. Photograph Locations

Figure 1 Photograph Locations

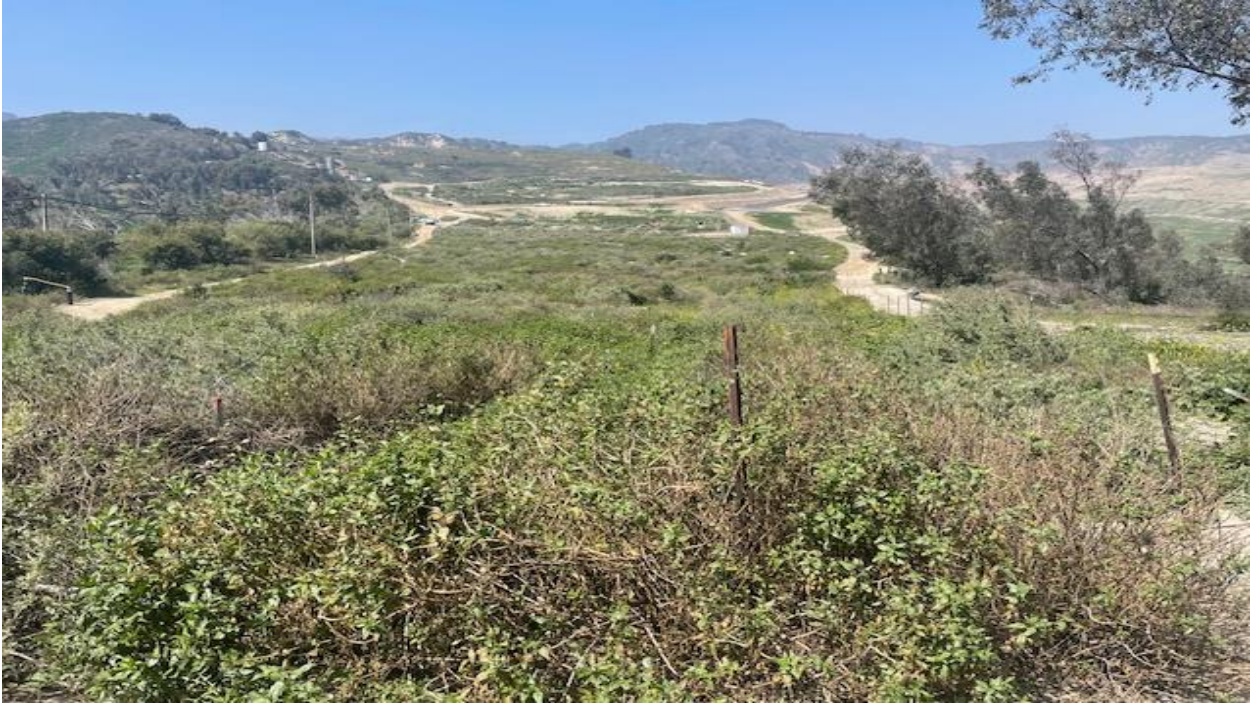
Photograph 1. Facing west at Lower Deck. View of eastern limits dominated by *Atriplex* spp. and California sunflower (March 21, 2024).

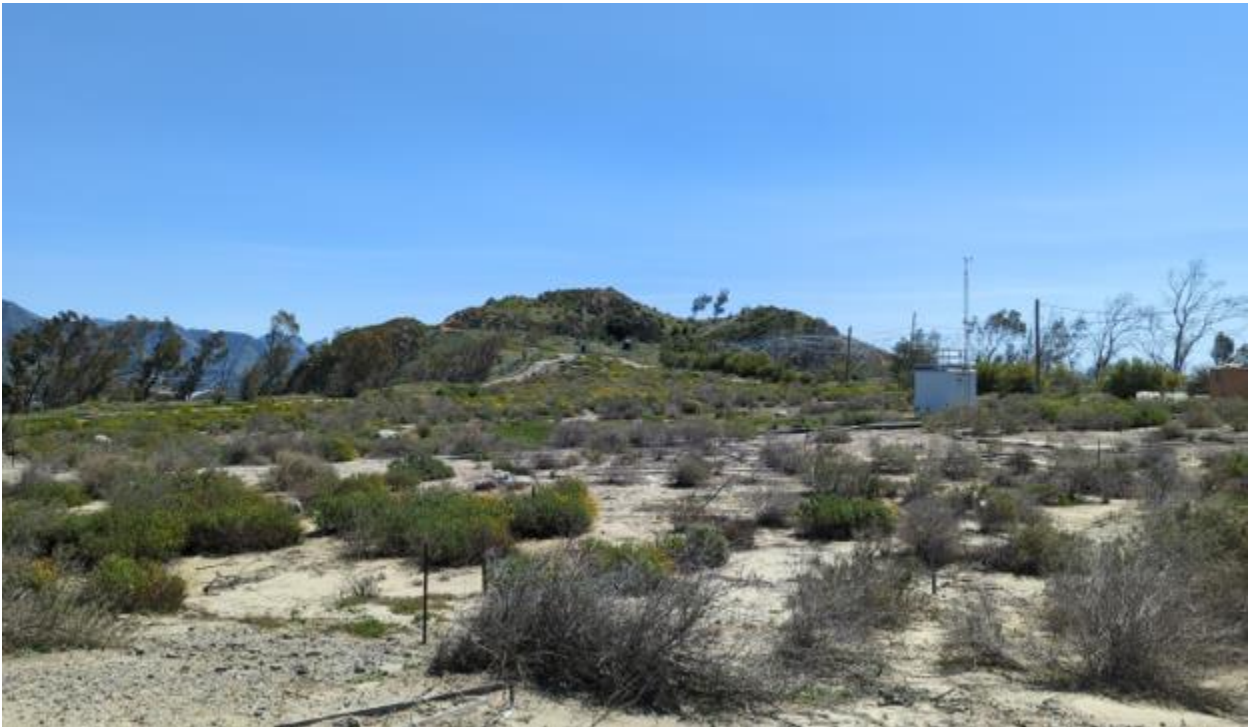
Photograph 2. Lower Deck from western boundary (March 21, 2024).

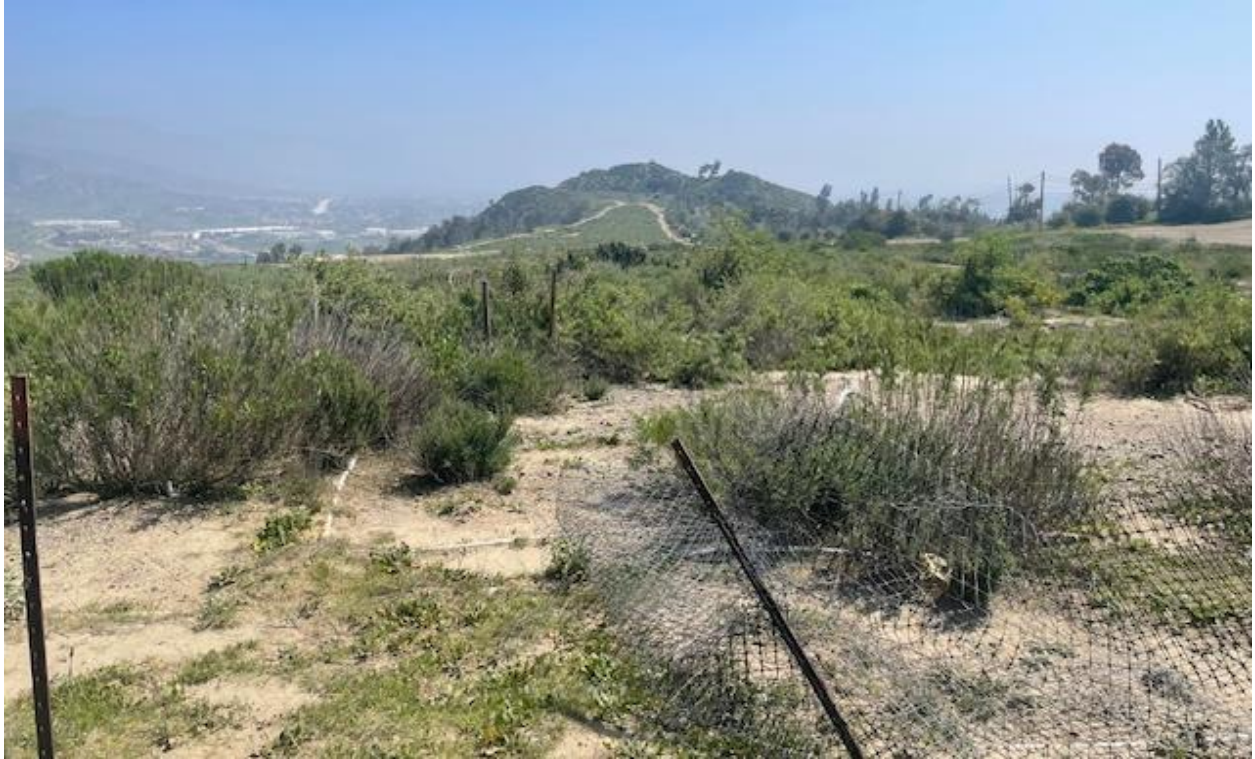
Photograph 3. Facing east at the Middle Deck from western boundary (March 21, 2024).

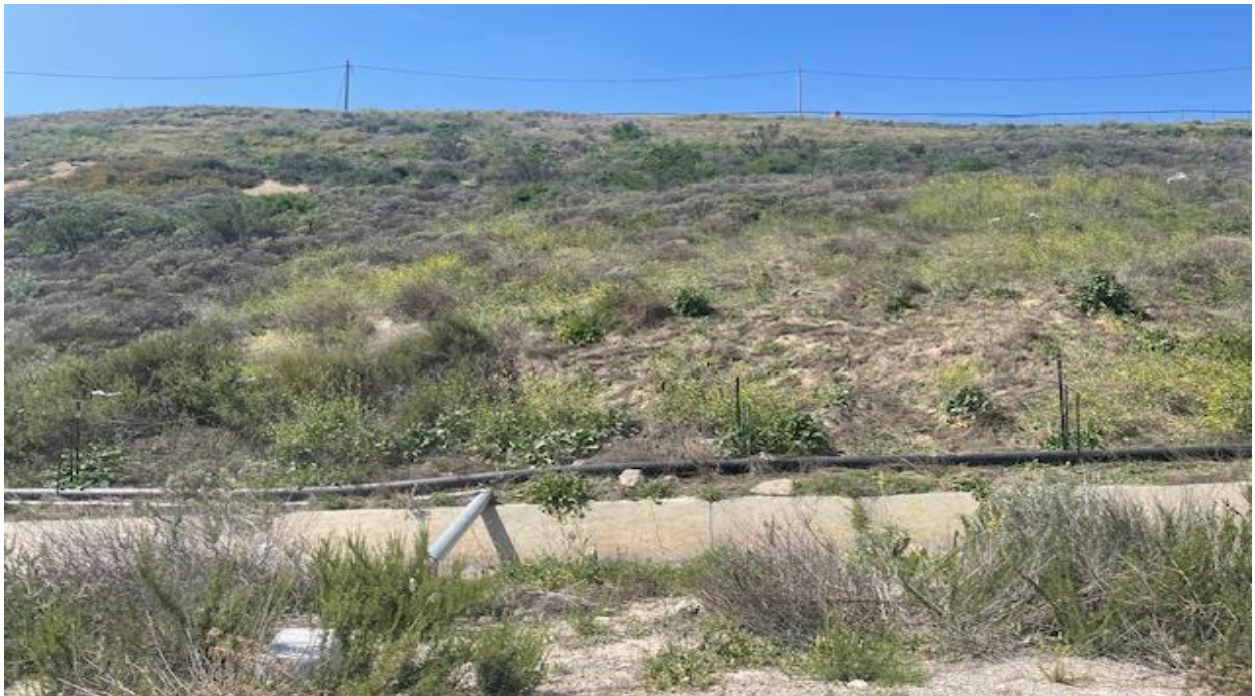
Photograph 4. Facing west at the easterly-facing slope located between the Middle and Upper Decks. The vegetation on the slopes between the Upper Deck is dominated by California buckwheat (currently vegetative) and non-native annual grasses (March 21, 2024).

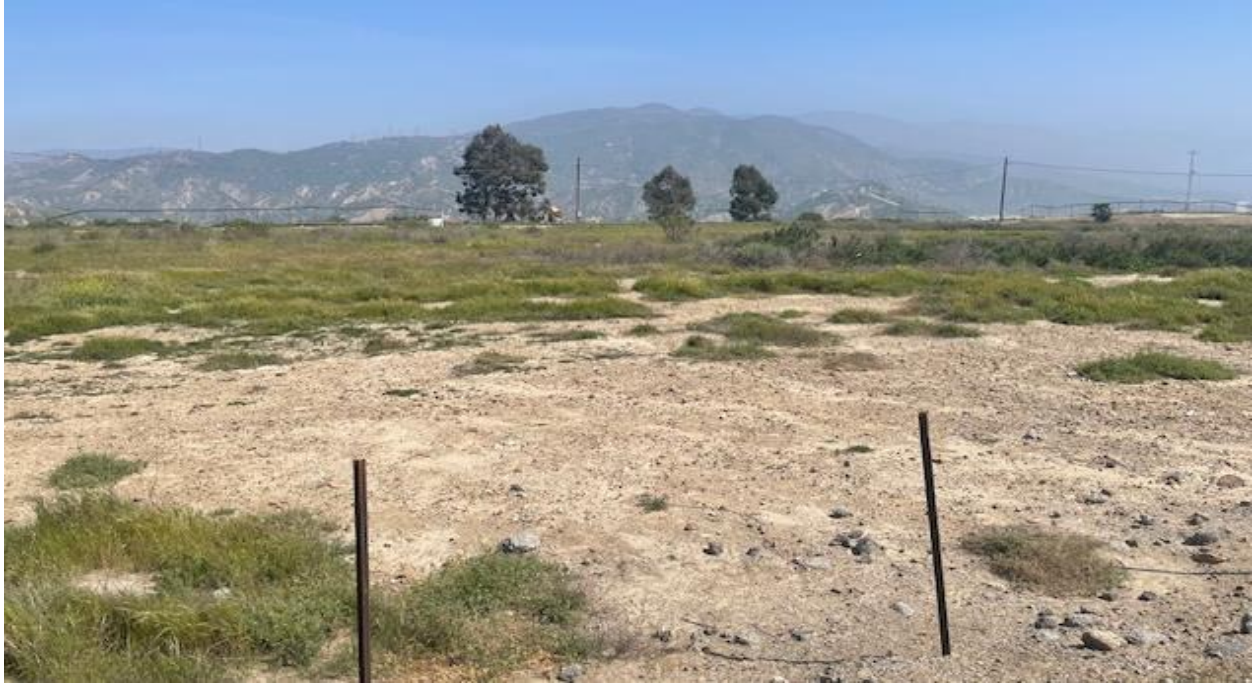
Photograph 5. Facing northeast at the Upper Deck. This area is compacted and gravelly and continues to be problematic for supporting vegetation. Non-native annual grasses and forbs, and California buckwheat shrubs are evident in the background (March 21, 2024).

- The vegetated areas on the Upper Deck that are currently dominated with non-native annual species have decent soil-texture conditions. These areas are less compacted than adjacent areas that are gravelly and mostly devoid of vegetation. In general, the soil texture within the vegetated areas with non-native vegetation is friable down to approximately 8-12 inches in

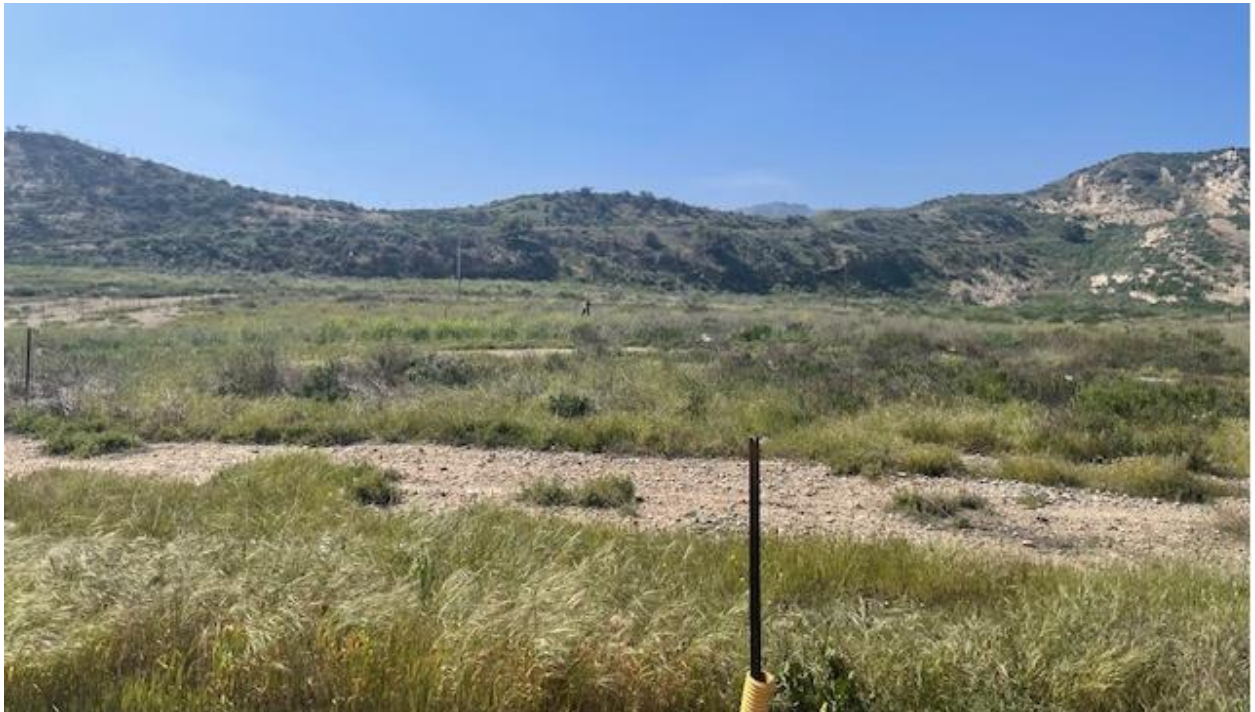
Photograph 6. Facing southwest at the Upper Deck. This area is primarily dominated by wild oats, brome grasses, redstem filaree, and short podded mustard. Note flowering California goldfields on the right side of the photograph (March 21, 2024).

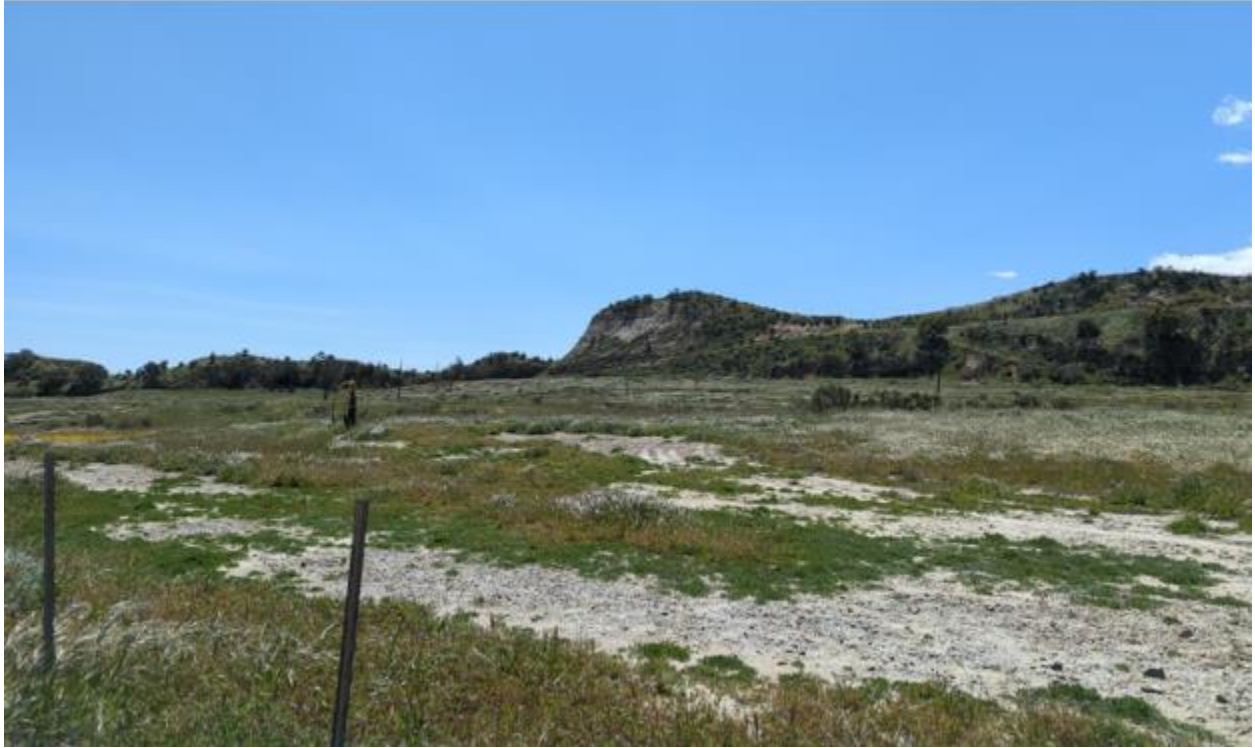
Photograph 7. Facing southeast at the western portion of the Upper Deck. This area is dominated by short podded mustard, Australian saltbush, and Russian thistle (March 21, 2024).

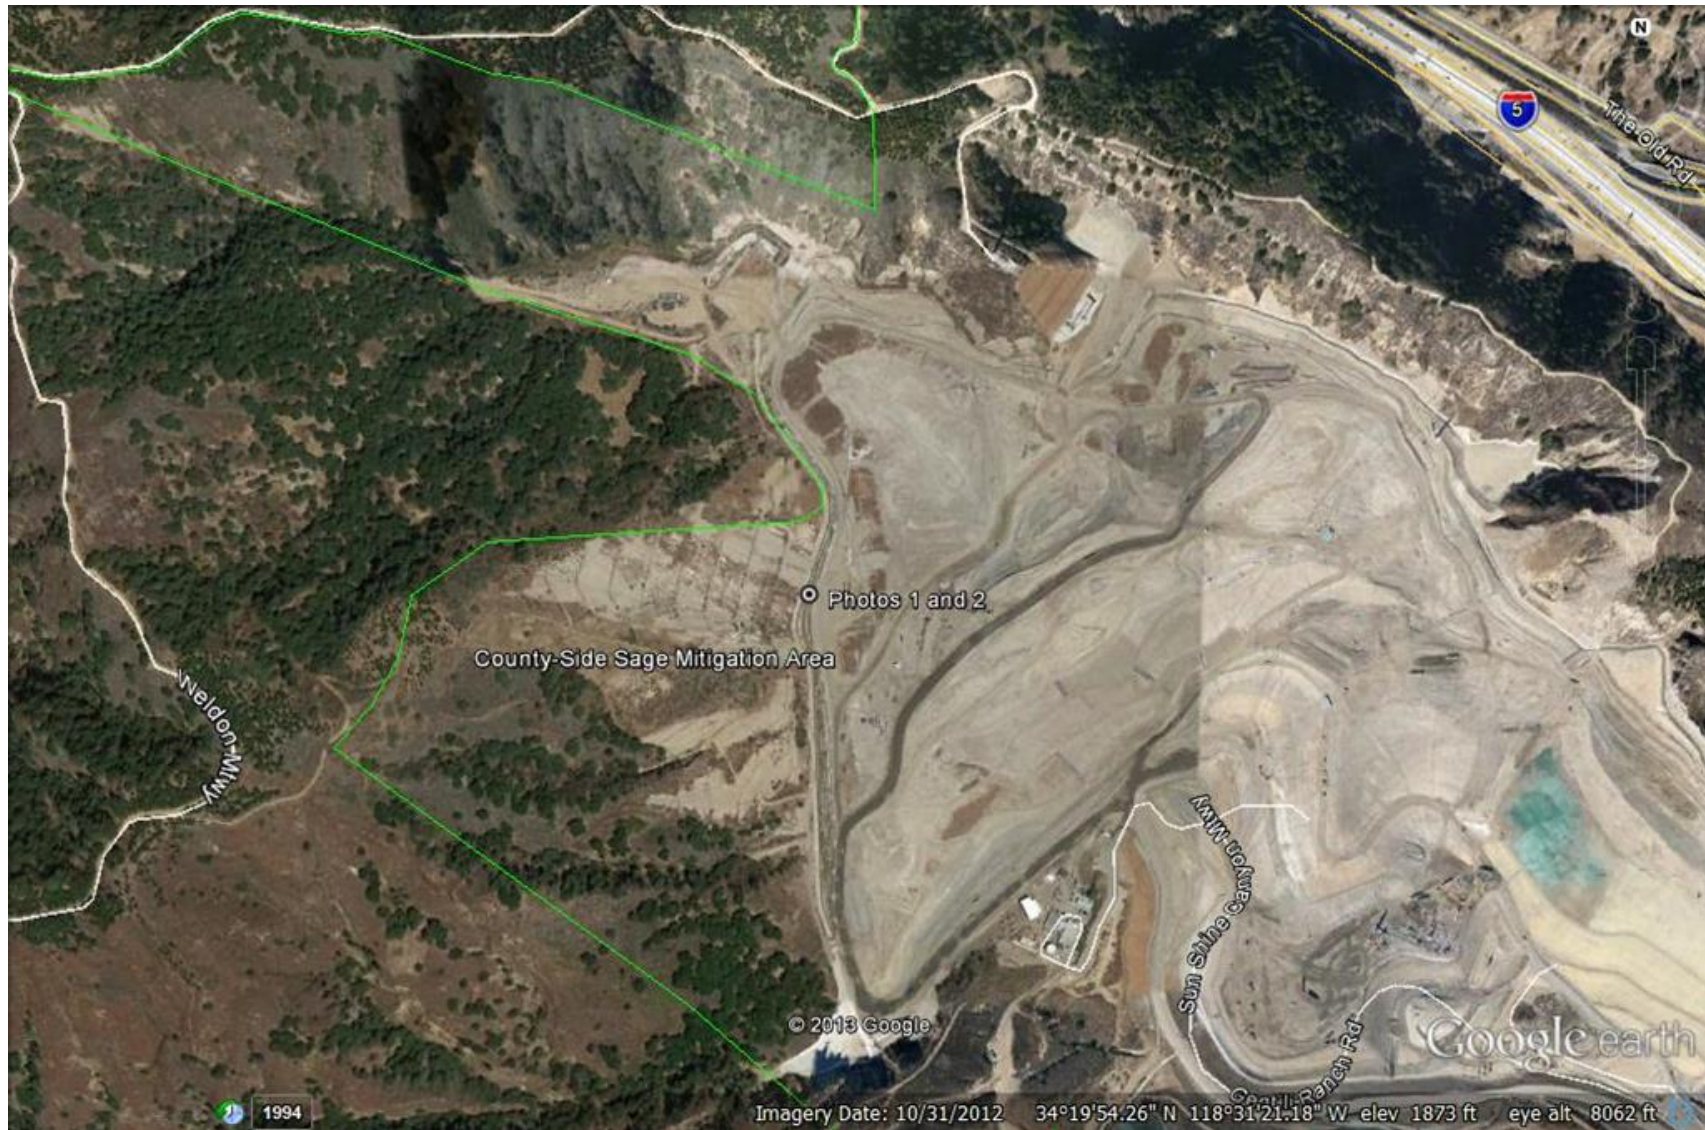
Figure 1. Photograph Locations

Figure 1 Photograph Locations

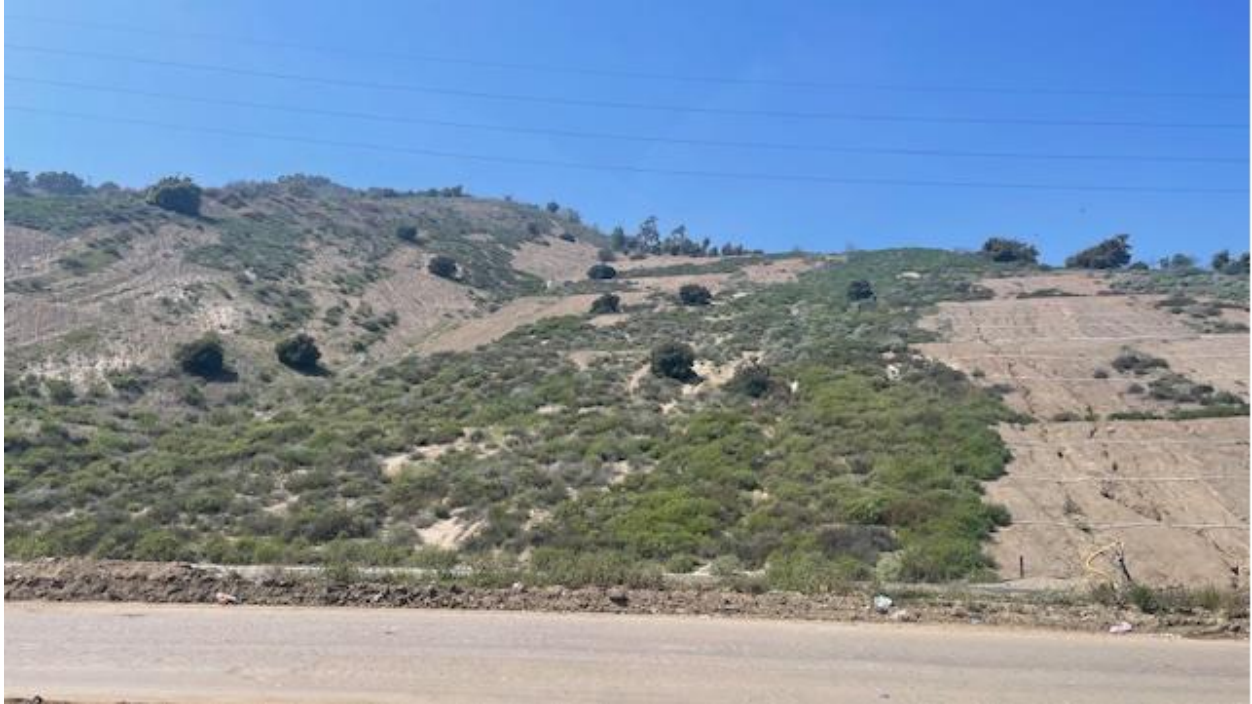
Photograph 1. Facing southwest at the County-Side Sage Mitigation Area (March 21, 2024).

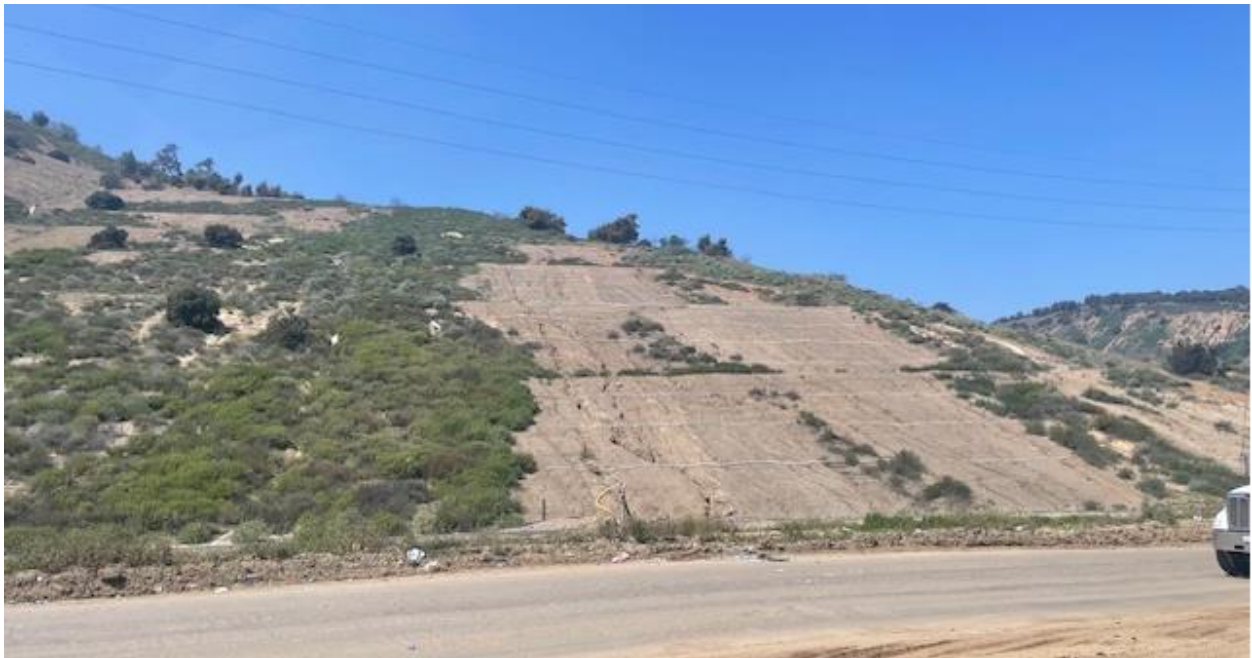
Photograph 2. Facing northwest at the northern portion of the County-Side Sage Mitigation Area where plant growth has been problematic due to poor soil conditions (March 21, 2024).

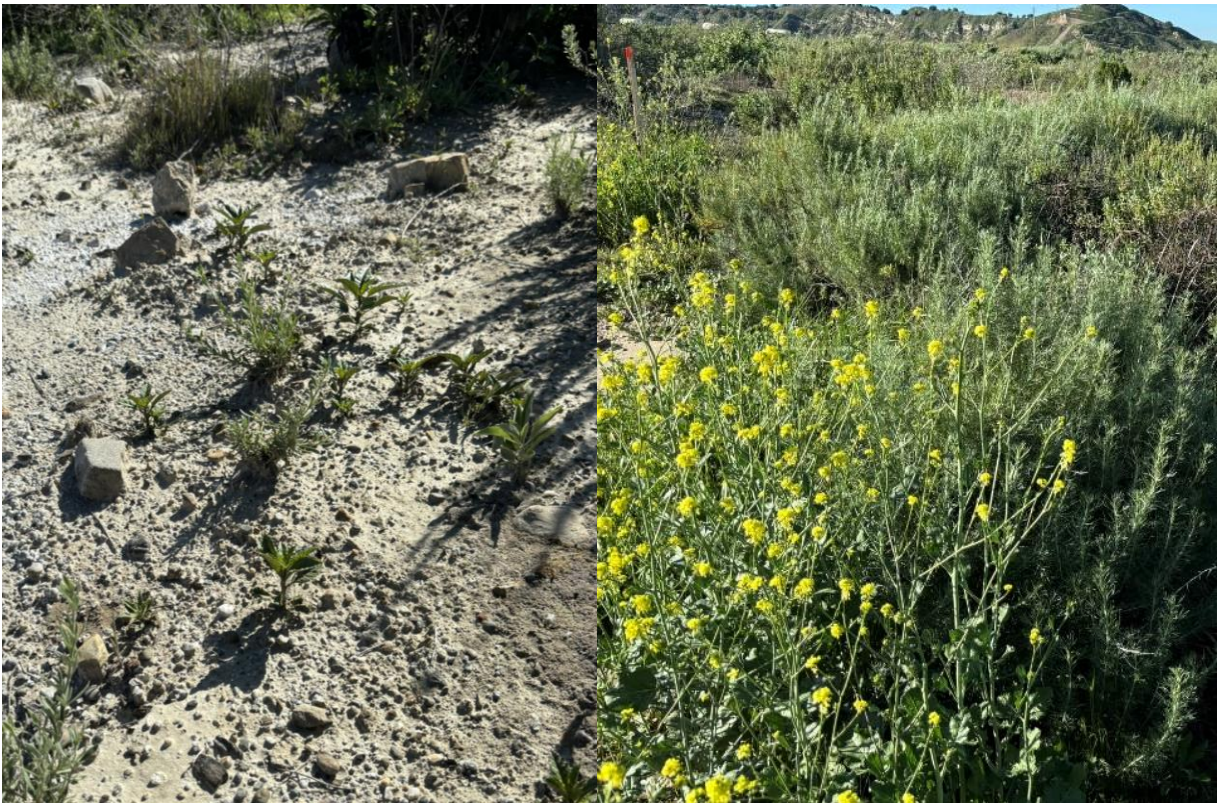
New native seedlings of California Sagebrush (*Artemisia californica*) and Yerba Santa (*Eriodictyon californicum*) on left and invasive Shortpod Mustard (*Hirschfeldia incana*) on right

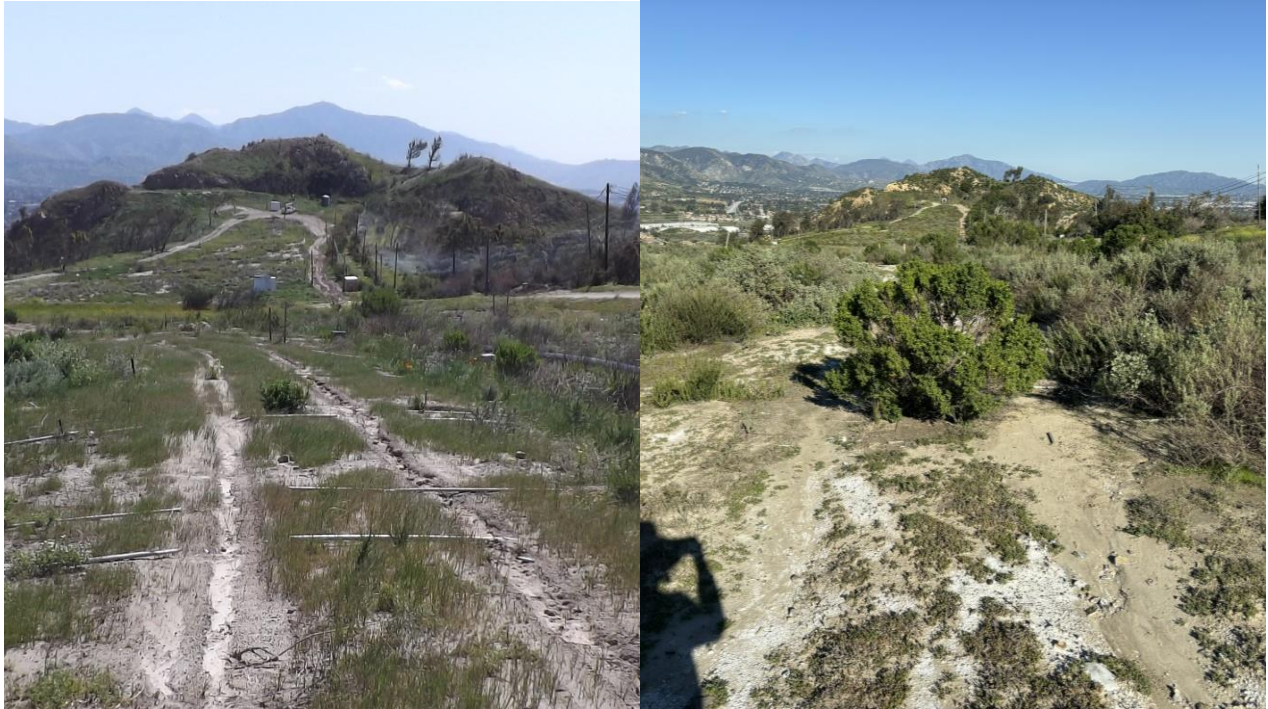
Side by side comparison of revegetated former gas well access road (image on left from April 2020, image on the right from April 2024)

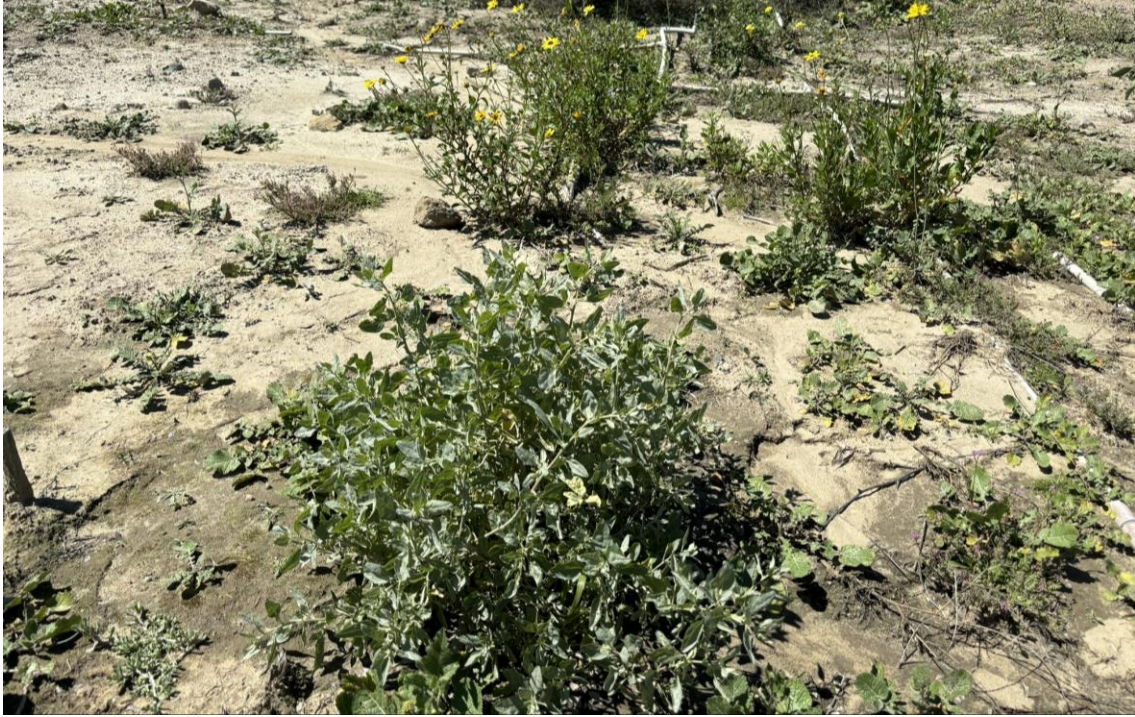
- Due to the above average rainfall for 2023/2024, and consistent low temperatures this spring, weed growth, along with native seed germination, has increased when comparing the quarter with previous years. Weed germination on Deck B is dominated by Shortpod Mustard (*Hirschfeldia incana*), Tree Tobacco (*Nicotiana glauca*), Russian Thistle (*Salsola* spp.), Yellow Star Thistle (*Centaurea solstitialis*), and Common Sowthistle (*Sonchus oleraceus*). Along with the invasive weeds listed, the following native Venturan Coastal Sage Scrub species have also germinated: Saltbush (*Atriplex* spp.), Coast Sunflower (*Encelia californica*), California Sagebrush (*Artemisia californica*), and Coyote Bush (*Baccharis pilularis*). Invasive weeds are intermixed with native seedlings, so inspection by the contractor to flag and identify native species is critical; removals should minimize disturbance of seedlings. Over time, native species will help to crowd out the invasive species, but weed growth should be kept at bay and managed.

Saltbush and California Sunflower sprout up amongst Shortpod Mustard

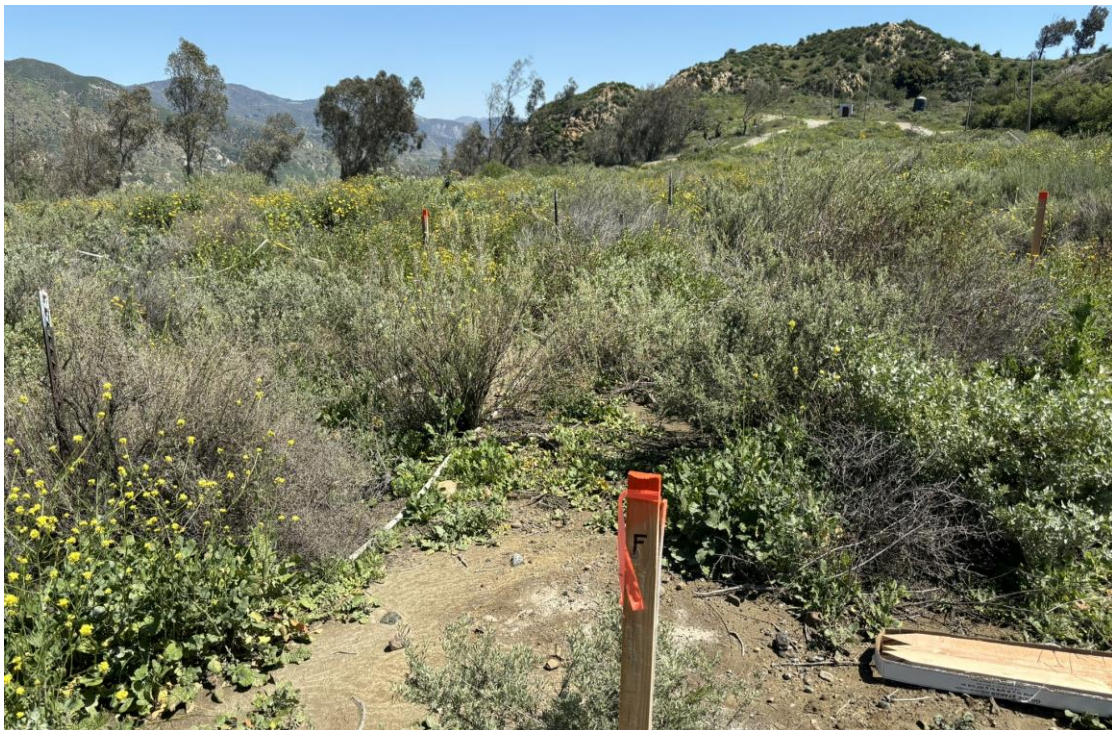
- Quadrats were marked and staked with taller stakes to help locate the twelve (12) random locations previously noted as part of the biologist's quarterly reports. Each quadrat is marked with the corresponding letter and flagged on the southwest corner stake.

Example of newly staked Quadrat F

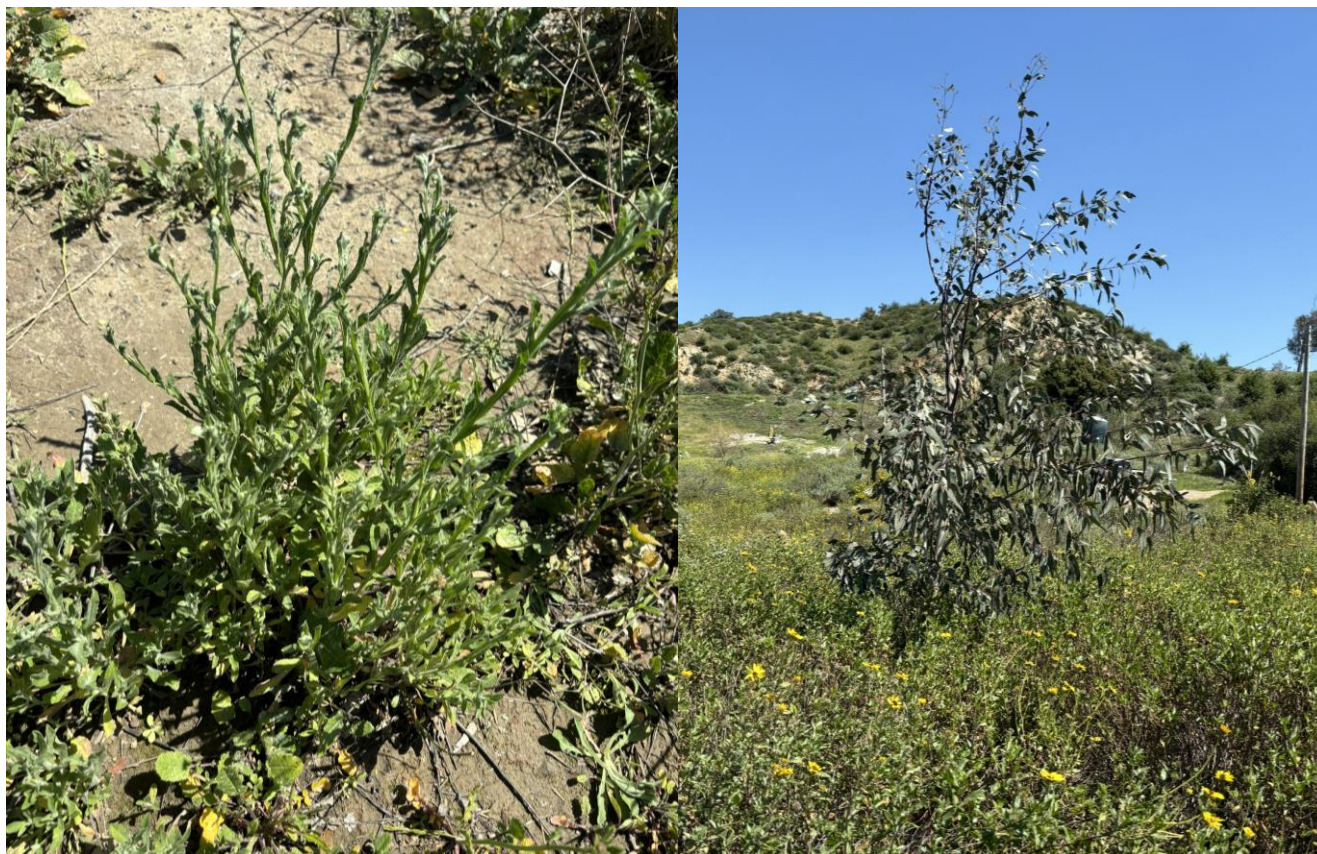
Invasive Yellow Star Thistle (*Centaurea solstitialis*) on left, Eucalyptus sp. on right

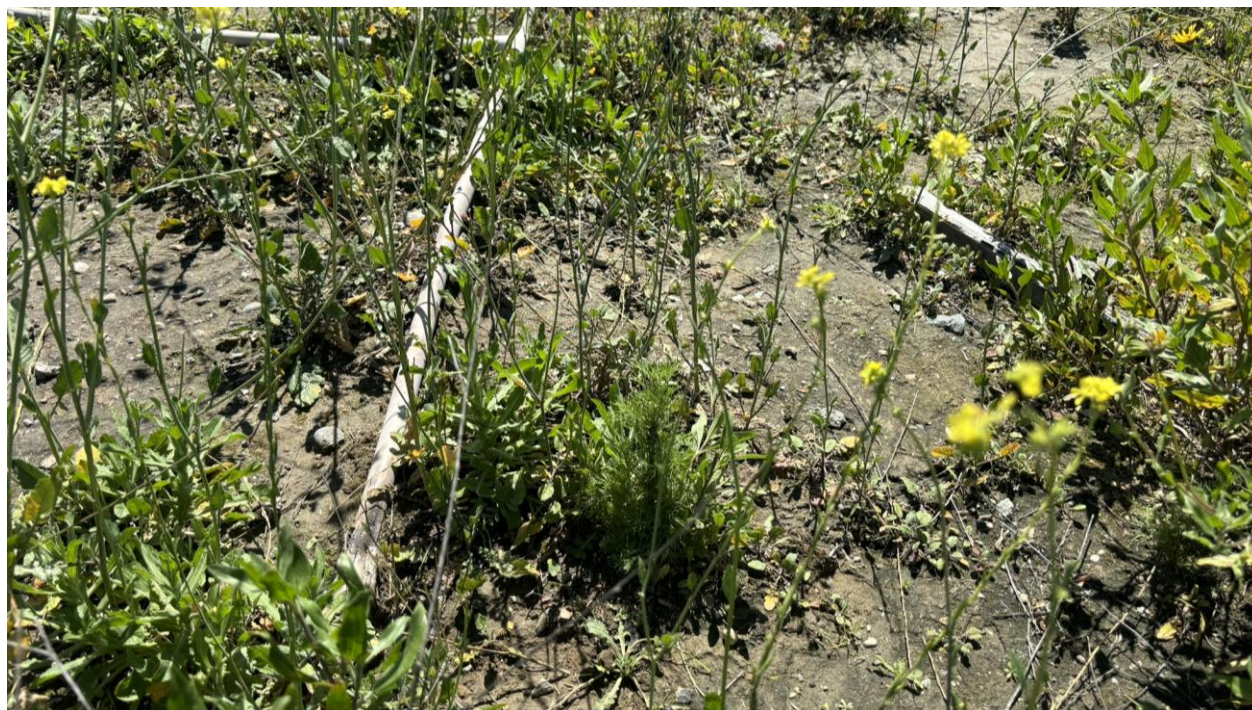
Invasive Shortpod Mustard (*Hirschfeldia incana*) with seedlings of Coast Sunflower (*Encelia californica*) and California Sagebrush (*Artemisia californica*) intermixed within weed growth.

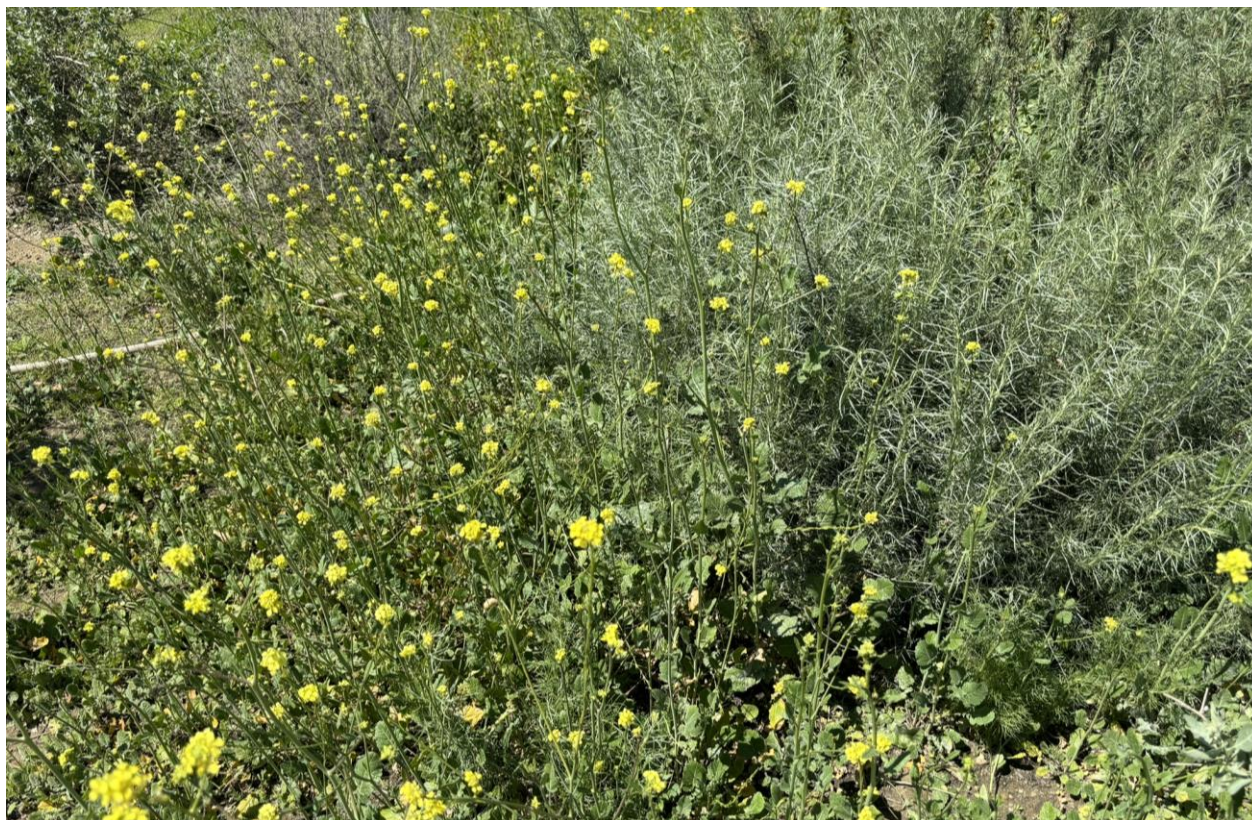
Shortpod Mustard (*Hirschfeldia incana*) crowds California Sagebrush seedlings

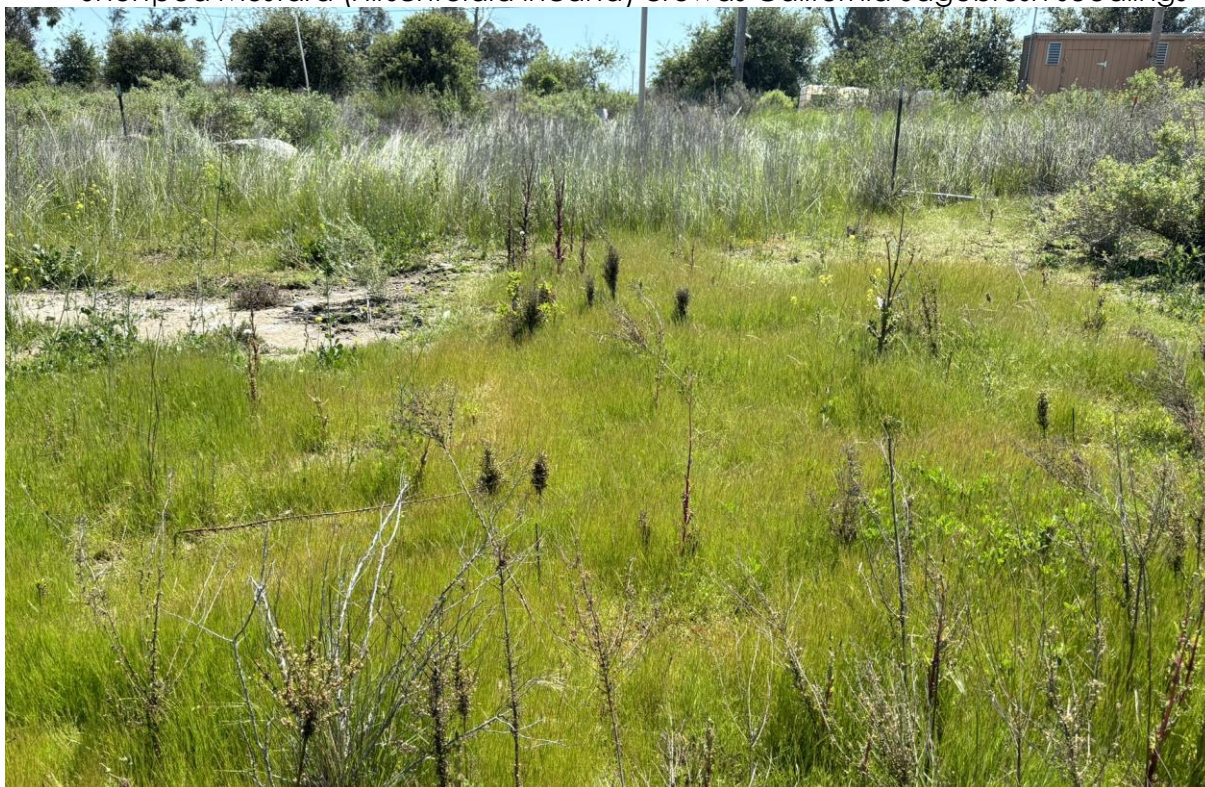
Invasive Common Sowthistle (*Sonchus oleraceus*) and Horseweed (*Erigeron canadensis*) within reestablished native Wild Rye (*Leymus triticoides*)
